Changes in Coastline with Landsat Imagery Approach and Its Impact on the Pattern of Development of Coastal Settlement Areas (Case of Indramayu Regency)

This research is entitled Changes in Coastline with Landsat Imagery Approach and Its Impact on the Pattern of Development of Coastal Settlement Areas (Case of Indramayu Regency). Problems Changes in the coastline in the coastal residential area of Indramayu Regency have an average abrasion rate of 23.64 Ha/year and an average accretion rate (sedimentation) of 4.81 Ha/year, making it difficult to develop the area for residential areas. This condition results in frequent changes in the area and policies on the development of coastal settlement areas in Indramayu Regency. The changes in the coastline can be seen spatially by using images such as Landsat images. Analysis method used is; land capability unit analysis (land capability), analyst is land physic, accessibility analysis, environmental infrastructure analysis, and GAP analysis (Gap Analysis). Changes in the coastline in Indramayu Regency, researchers used time series image data, namely by using Landsat imagery in 2000, 2005, 2010, 2015 and 2020. The largest shoreline changes

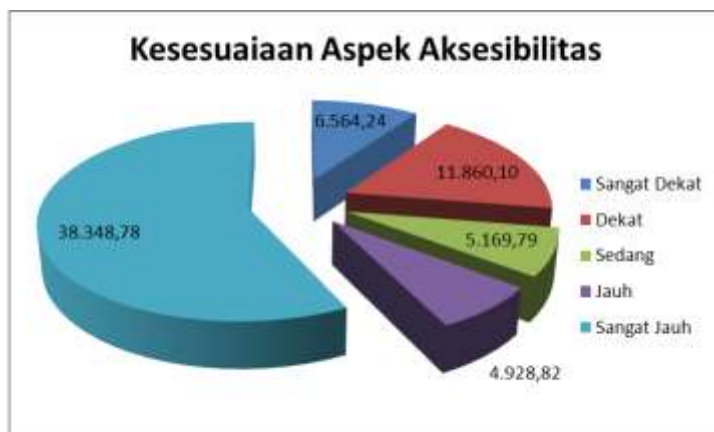
Figure 8. Area of Suitability Aspects of Accessibility

Thus, it can be concluded that the closer the road distance to the residential area, the higher the quality of accessibility.

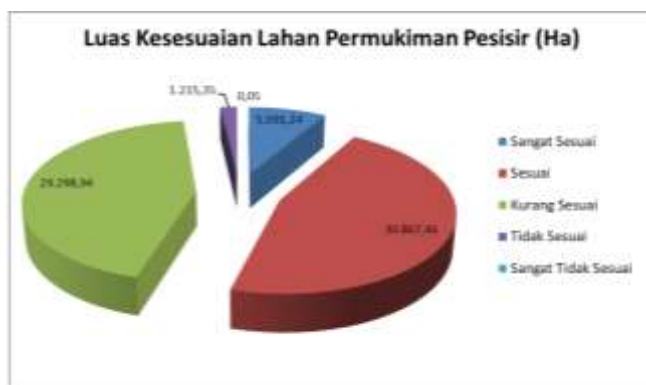
Figure 11. Results of the Aspects of the Suitability of Settlement Land in the Coastal Area

The analysis of land suitability for coastal settlements in Indramayu Regency above is an overlay of all the above aspects by considering coastal and river boundaries which are important considerations in determining

residential areas. Based on the results of the analysis above, the land area that is very suitable is 8.35% or an area of 5.591.24, while the area that has the largest designation area is at the level of suitability, which is 30,867.46 ha or about 46.09%.
