Feasibility Of Materials With Analytical Hierarchy Process (AHP) And Its Impact On Users Of Parks In The Historic Center, Lima-2019

Table 1. Failures in urban material in squares and parks in the Historic Center of Lima, 2019.

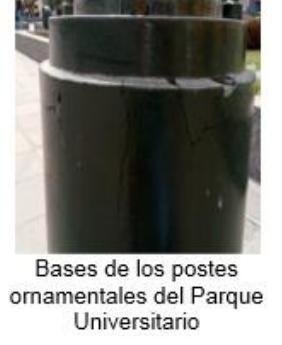
Figure 1. Main failures in urban material in squares and parks in the Historic Center of Lima, 2019.

Tachos de basura de la Plaza de Armas

Árboles sin alcorques en la Plaza San Martín

Bases de bancas de Plaza Italia

Tachos de basura en la Plaza Helguera

rusted bases.

Bancas en la plaza Alameda de los Descalzos

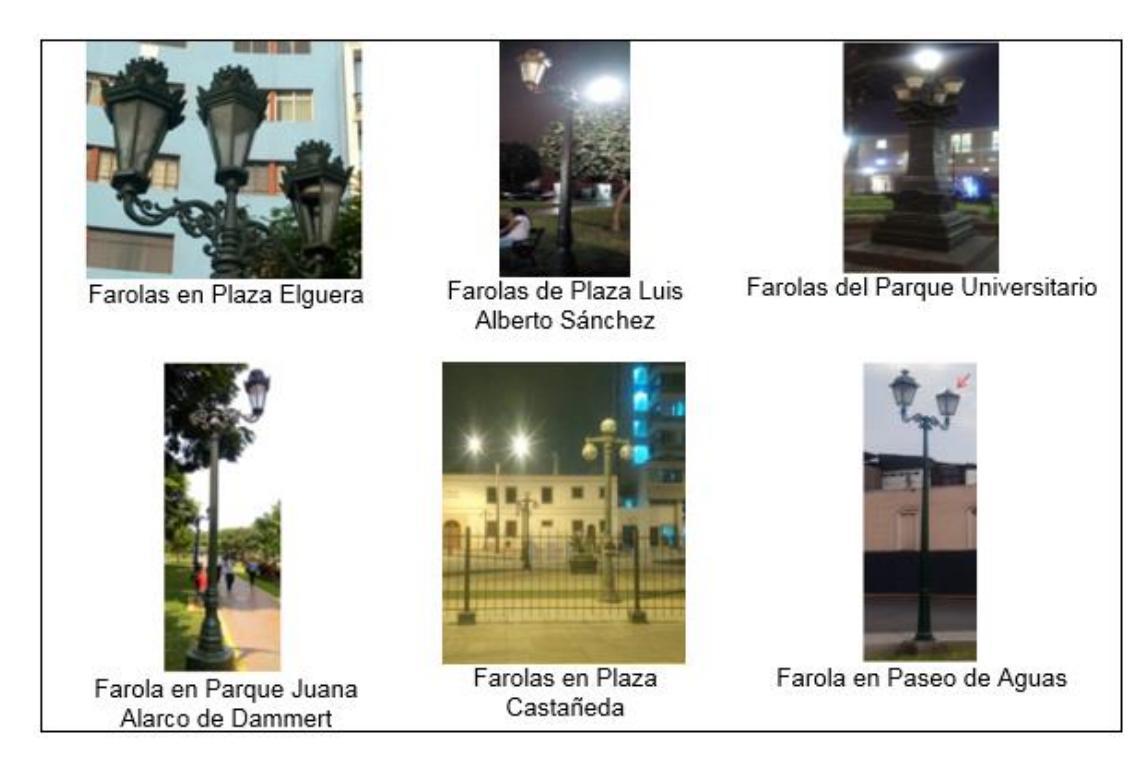
Figure 2. Main failures in lighting systems in squares and parks in the Historic Center of Lima, 2019.

Table 3.	Main	failures i	n lighting	systems in	n squares and	parks in	the	Historic	Center	of Lima,	2019.	
												_

Location	Lighting failures			
Plaza Alameda de los Bobos	Dirty glass. Rain type glass.			
Plaza Alameda de los Descalzos	Dirty glass. Rain type glass. Asymmetrical streetlights. Lighting on only one side of the square.			
Paseo de Aguas	Dirty glass. Rain type glass. Asymmetric lanterns. Street lamps without cover.			
Plaza de Armas de Lima	Dirty glass. Rain type glass.
